SUBJECT: Transmittal of the September 2013 Fernald Preserve On-Site Disposal Facility Inspection Forms

On-Site Disposal Facility Inspection Report

September 2013

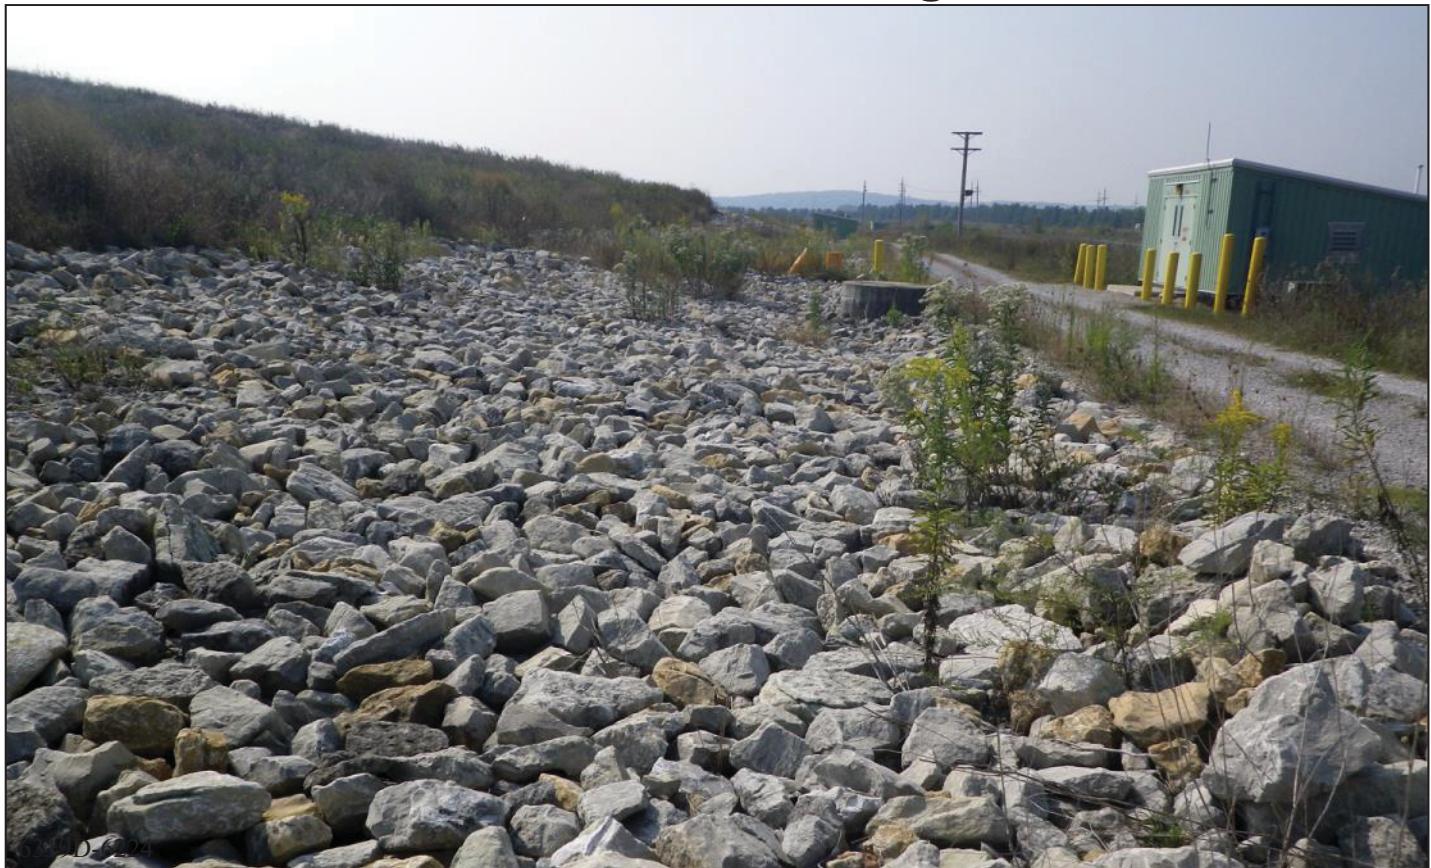
West Inner Drainage Cell 7 (looking south)

Inspectors continued to observe restricted flow in several locations along the west inner drainage. Repair efforts in February 2013 were successful in restoring flow at one location near Valve House 6. Small-size angular stone and fines (from the adjacent gravel road) were constricting flow. The stone and sediment was removed with a skid steer and flow was improved. This same approach was attempted at a second location in June 2013, but more sediment was encountered than anticipated. In addition, it appeared that the concrete outfall structure was not draining as designed. Water was draining into the structure, but from a concrete seam rather than the inlet.

Upon discovery of this, it was determined to discontinue maintenance activities and evaluate the need for further action. A "follow-up" inspection of the issues associated with the west inner drainage will be provided separately, pursuant to Section 7.2 of the Post Closure Care and west inner drainage will be provided separately, pursuant to Section 7.2 of the *Post Closure Care and Inspection Plan*.

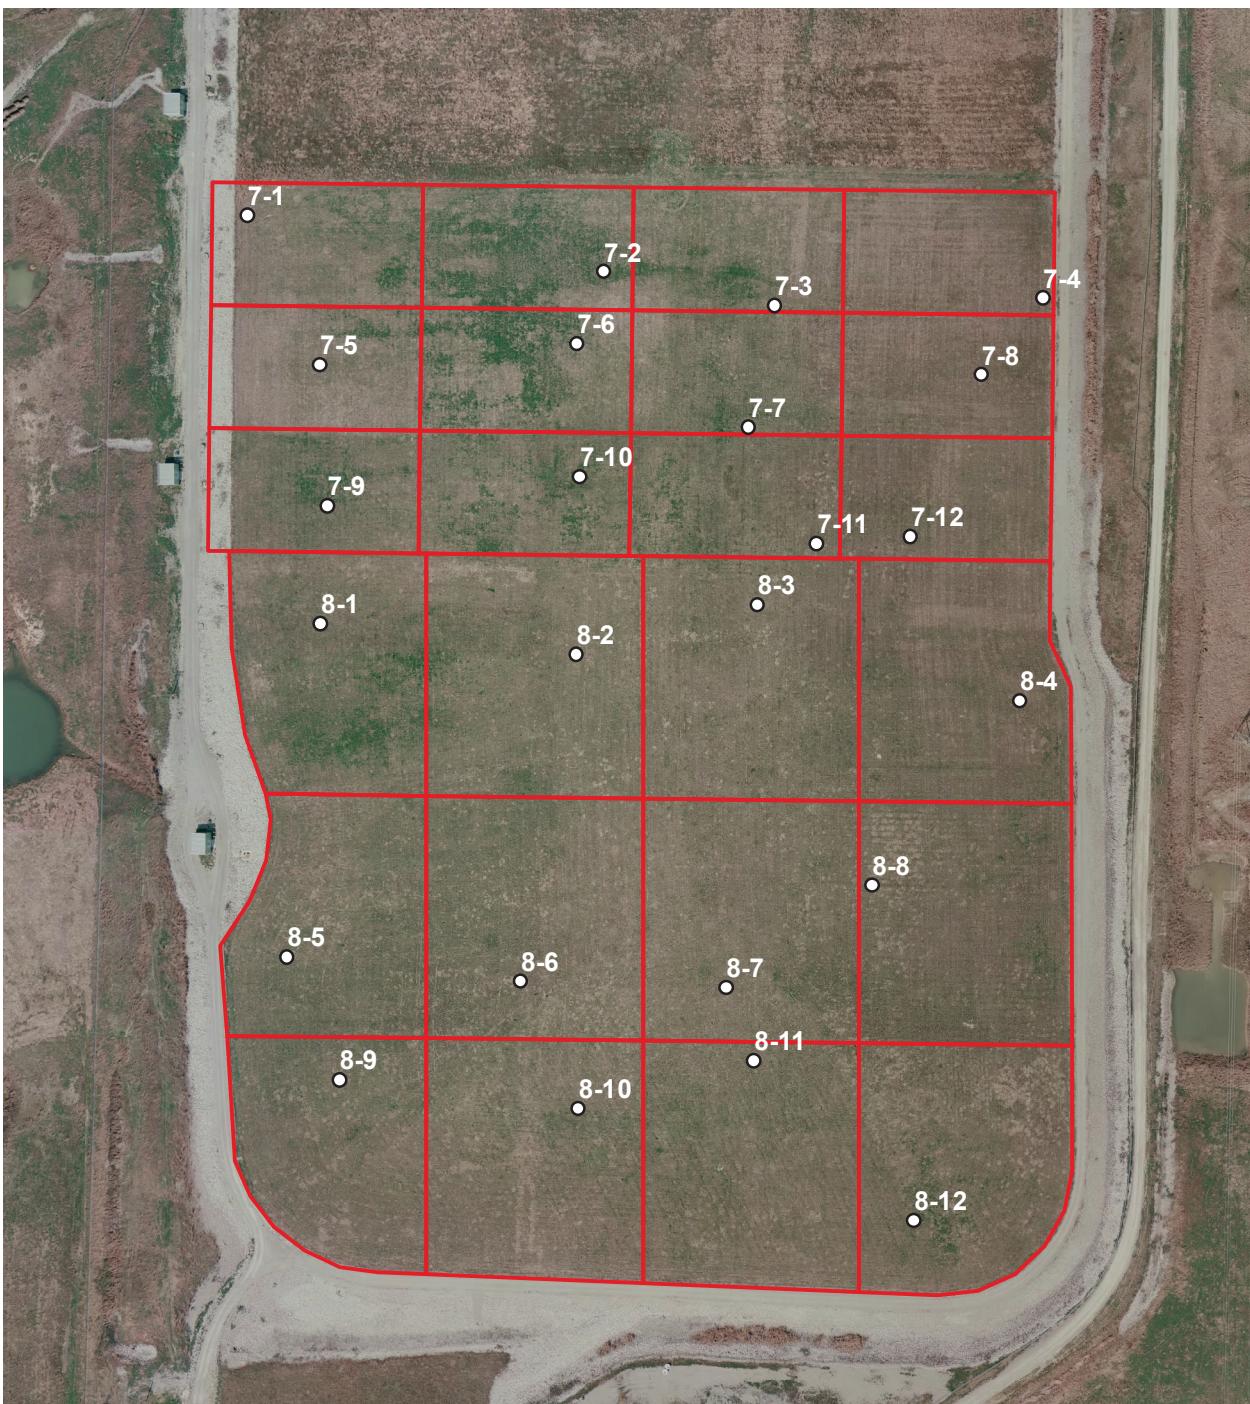
Fernald Preserve
OSDF Implementation
Monitoring

Pursuant to Volume II of the LMICP, herbaceous cover data was collected for Cell Caps 7 and 8. For each cell cap, 12 one-meter square quadrats were randomly located using a three by four grid. The enclosed figure shows the grid and quadrat locations for each cell cap. Field surveys were conducted on August 23 and August 27. Total cover and species richness data were collected for each quadrat. From this information, total cover, native species composition and relative frequency of native species were calculated. The table below summarizes the findings. The enclosed data tables present cap-specific species lists.

The LMICP goals for the OSDF cap include 90% total cover and 50% native species composition. The data collected on Cells 7 and 8 demonstrate that native vegetation is being maintained across both cells. Native species composition is above 50% for both caps. Total cover is close to 90% for Cell Cap 7, but less than expected for Cell Cap 8. It is suspected that yellow sweet clover (*Melilotus officinalis*) contributed to reducing total cover on Cell 8. A large number of plants were observed in bloom earlier in the year. By the time the field data was collected in August, the plants had died off. These plants may have shaded out other species that did not re-establish later in the season, resulting in less total cover in August. Nevertheless, the integrity of the cap appeared intact, as no erosion was observed on either cap.
